Manhole Inspection Summary

Manhole # S65S__001MH

Insp Date: **3/6/08 2:18 PM**

Location Address: **1533 Elrino St.**

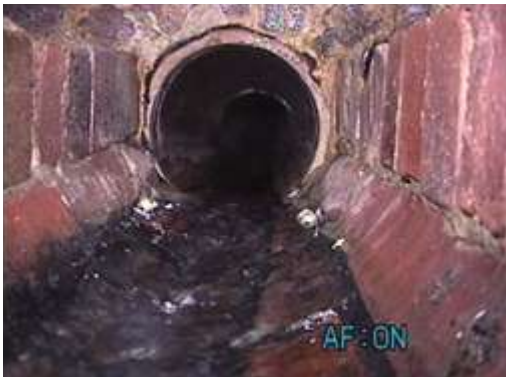
Defect 1

cracked pipe seal 9:00-2:00 incoming 6 O'Clock

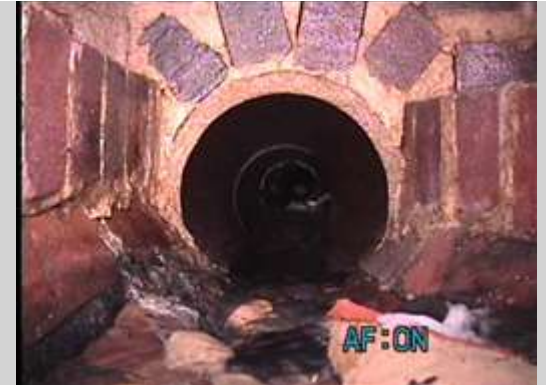
12 O'Clock Outflow

8 in. Circular Gravity Sewer
Pipe Out @ 12 O'Clock

Pipe Height: **8.4** (in.) Rod and Bar (Angled)
Pipe Material: **Clay** ☐ Pipe Lined
Invert Depth: **9.58** (ft.) Flow Characteristics: **Fast**
Deposits: ☒ None ☐ Mud ☐ Sludge ☐ Debris ☐ Grease
Silt Depth: (in.) Deposits Extent:
Infiltration: **None** Pipe Seal Cond: **Sound**

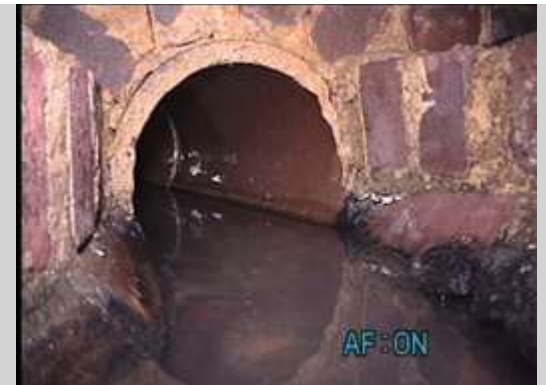
3 O'Clock Inflow

8 in. Circular Gravity Sewer
Pipe In @ 3 O'Clock

Pipe Height: **8.4** (in.) Rod and Bar (Angled)
Pipe Material: **Clay** ☐ Pipe Lined
Invert Depth: **9.50** (ft.) Flow Characteristics: **None**
Deposits: ☒ None ☐ Mud ☐ Sludge ☐ Debris ☐ Grease
Silt Depth: (in.) Deposits Extent:
Infiltration: **None** Pipe Seal Cond: **Sound**

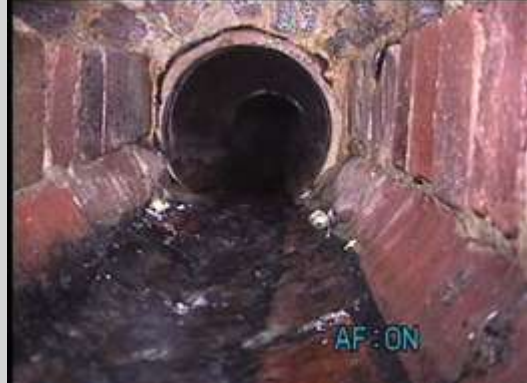
6 O'Clock Inflow

Infiltration: **Evidence** Pipe Seal Cond: **Cracked**
